Fitness For Service Assessment

API 579 ASME FFS 1

Case Studies: FFS Assessment

Isomerization reactor

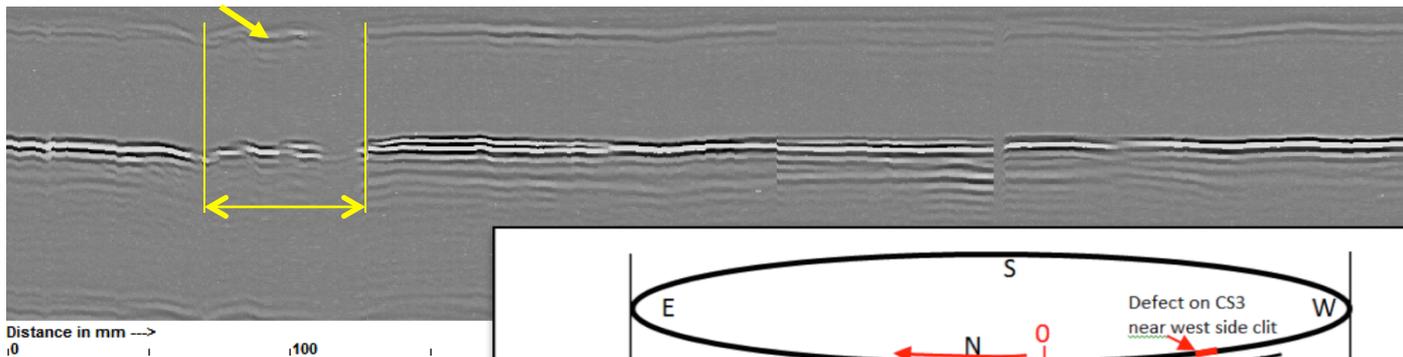
Drop in back wall echo with indication of flaw

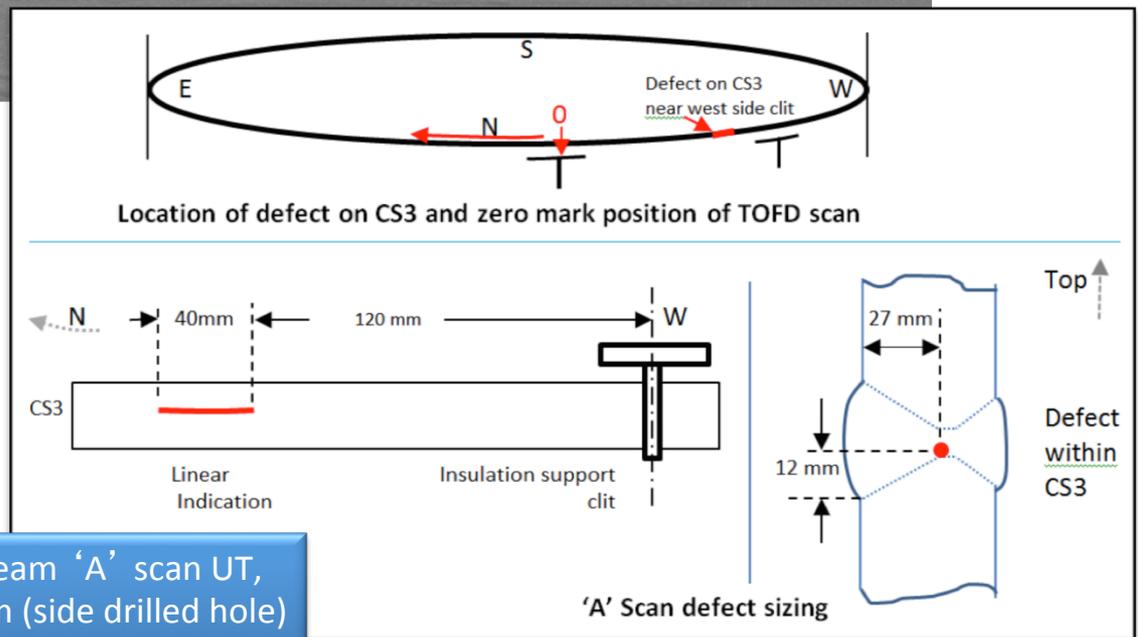
Defect sizing by angle beam 'A' scan UT, size equivalent to $\varnothing 4\text{mm}$ (side drilled hole) and 40 mm length

$$\text{Defect size at CS3} = (2a \times 2c) \\ = 4 \text{ mm} \times 40 \text{ mm}$$

$$a_{Cr} = K_{IC}^2 \times Q / (1.21 \times P_i \times (\sigma_{\text{total}})^2) \\ = 136^2 \times 0.8 / (1.21 \times 3.14 \times 18.78^2) \\ = 11.04 \text{ mm or } 2a = 22.08 \text{ mm}$$

All anticipated damage mechanisms	
Visual abnormality	No significant visual abnormality
Structural distortion	No significant bulging No change in verticality
HTHA	Did not show significant damage.
High temp. corrosion	No reduction in thickness
Microstructural properties	No significant degradation is observed from external surface. Grain size ASTM 9 to 10 everywhere
Weld joints	No defect observed in WFMPI Defect at CS3 has dimensions less than critical size
Simulation study	Heat simulation indicated the overall strength as acceptable as per minimum requirement of SA 516 gr 70
FFS calculations	The flaw at CS3 is acceptable considering FFS calculations

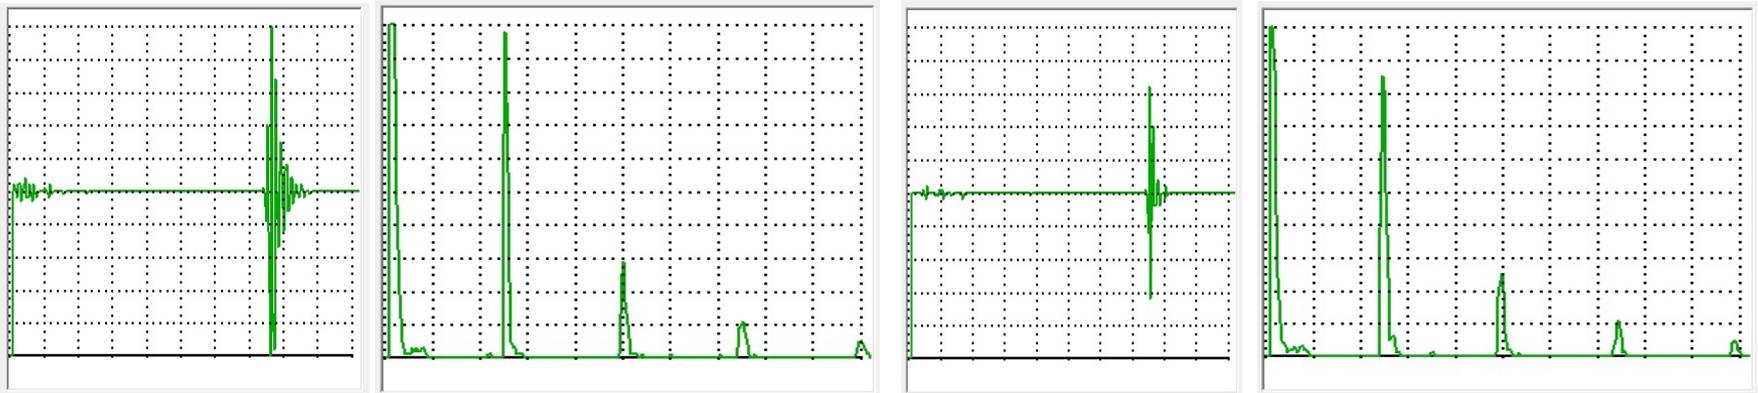
AUBT
Echo pattern at Shell 2

- Extent of coverage: First four shells: 100% scanned with 10% probe overlapping method
- Probes: 10 MHz
- References: (1) Guideline from API 941 (2) Comparison with away region
- No indication of HTHA observed anywhere

AUBT
Echo pattern Shell 8

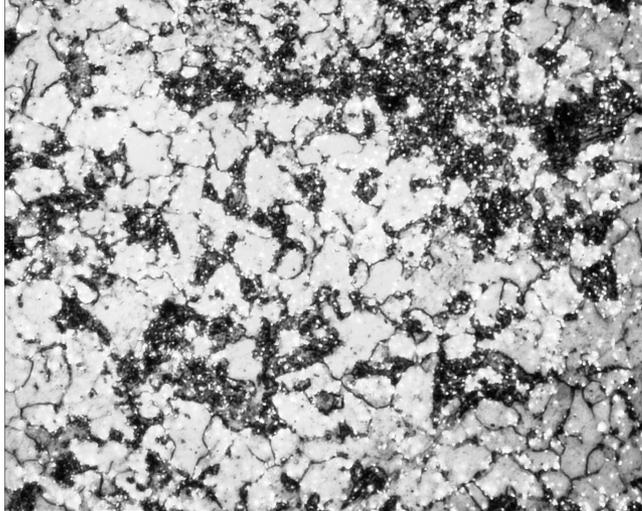
Structure at Shell 2

- Extent of coverage: Total 60 Locations (*Shell 2 : 16 locations*)
- Method: ASTM E1351 “Practice for production and evaluation of field metallographic replicas”
- Etching technique: Manual swabbing with 2% nital
- No significant change in microstructure is observed, microstructures show ferrite and pearlite structure. ASTM Grain size 9 to 10. No indication of pearlite degradation.
- **Heat excursion on external surface of shell is insignificant**

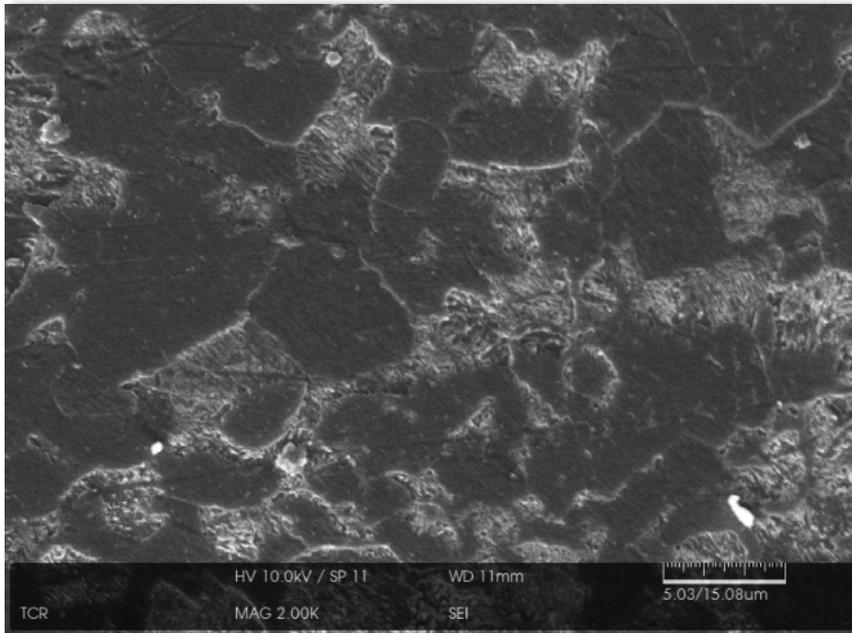
Structure from Shell 2

- Extent of coverage: 15% of replicated structures
- Magnification up to 3500X after Gold coating of replica
- Finding: Fine grained ferrite and pearlite structures
No significant difference in structures

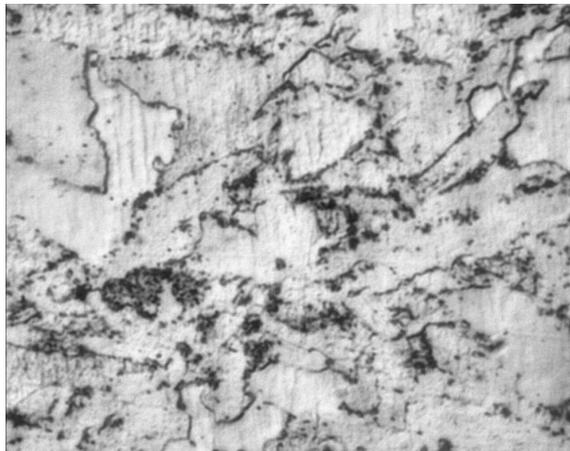
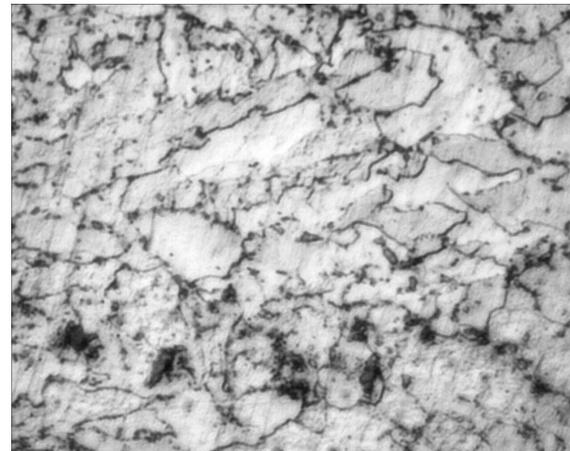
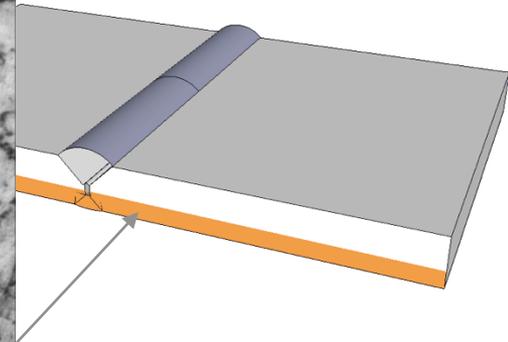
- Microstructure are of ferrite and pearlite.
- No significant change in grain size after simulated heat excursion.
- Minor effect of spheroidization of pearlite.
- No significant change in microstructural properties after short period temperature excursion up to 710°C

PWHT Coupon

PWHT + Heat simulated coupon (*Bottom*)
